Geoenvironmental assessment of magnesite deposit Jelšava - Dúbrava massif

SOŇA CICMANOVÁ

This article gives basic information on two main groups of geoenvironmental impacts originated from mining and processing activities realised on magnesite deposit of the Jelšava – Dúbrava massif: mining impacts from magnesite exploitation and impacts from magnesite processing. They differ in character (nature), time behaviour and scale.

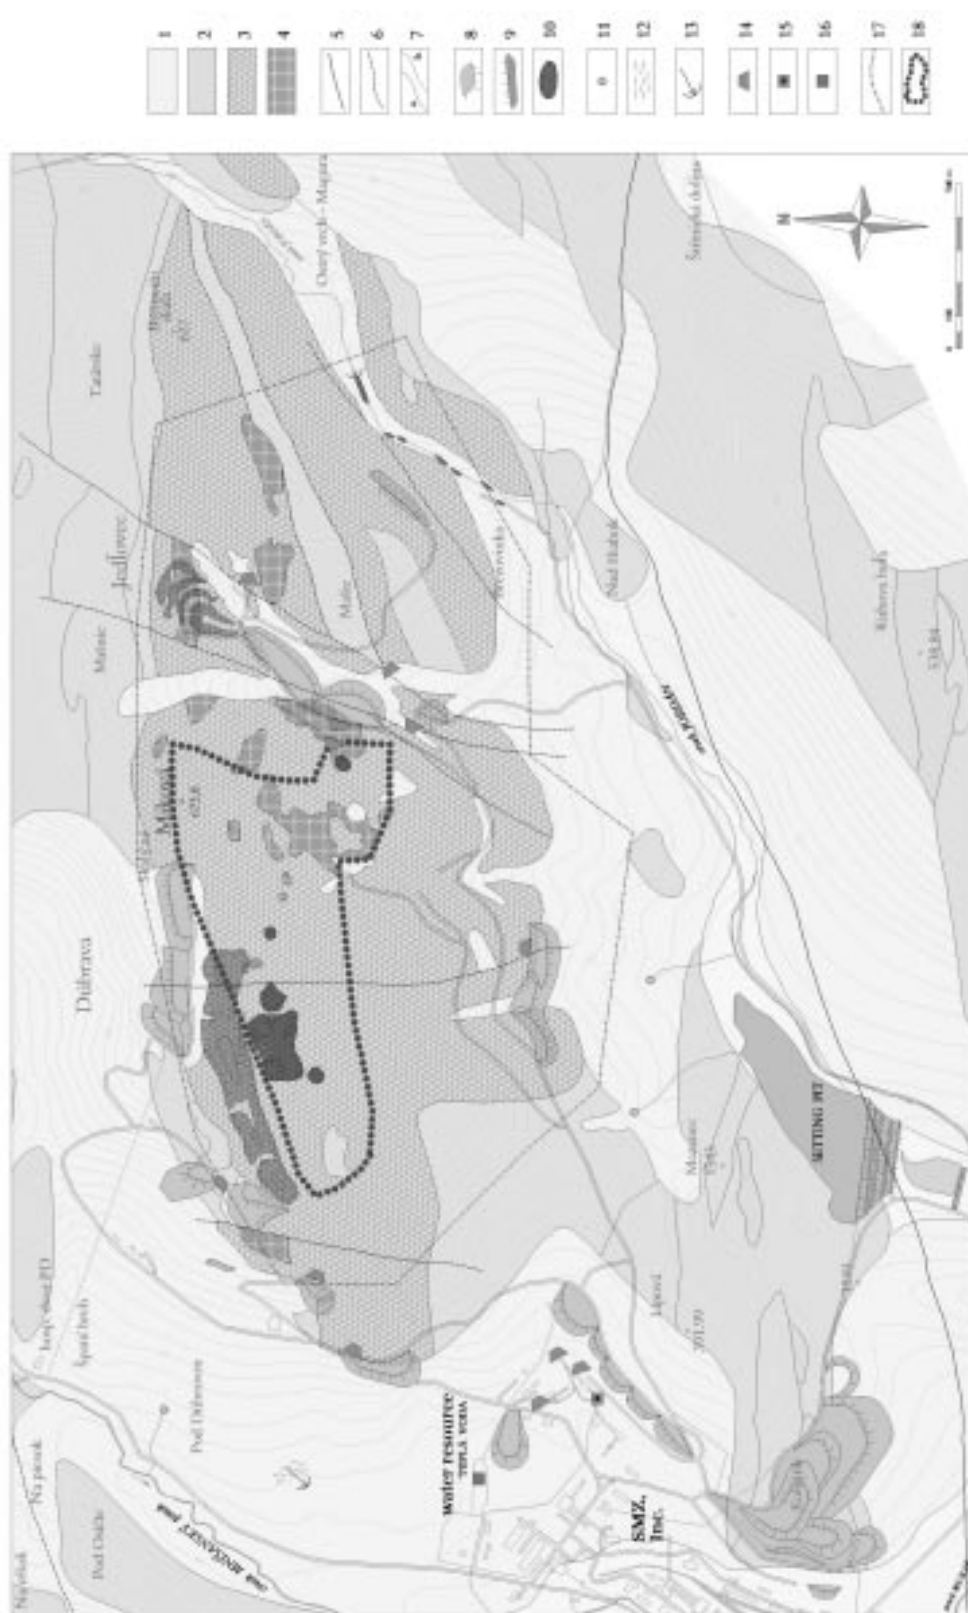
Fig. 3 Important geoenvironmental factors of Důbravský massif deposit (Cicmanová 2002)

studies realized there by different institutions. The main geoenvironmental factors connected to magnesite mining and processing on the Dúbrava massif deposit are shown on Fig. 3. We can divide them into two groups (Cicmanová 1995):

- *falls of terrain in consequence of undermining (deposit parts Dúbrava and Miková)*

Formation of widespread slots and terrain falls in the Dúbrava and Miková deposit parts were caused by synergic effect of two factors. Natural conditions (geological, tectonic, hydrogeologic, geomorphologic, karst phenomenon) are base factors, which condition the massif stability and resistance against undermining. Tectonic faults of carbonate rocks together with karst development formed weak zones. Younger tectonic – transverse tectonic lines of N-S direction and steep inclination – are important for interconnection of underground and surface. The second determining factor is the method of mining - rooming. Falling of terrain on localities Dúbrava and Miková is result of intensive mining by rooming method in the 1970s and 1980s.

- *destruction of significant water resources caused by mining works drainage*

Progress of mining works depthward and extension of their drainage effects through the karst phenomenon gave birth to terrain falls in the valley of the Jordán stream, based on a significant tectonic fault. At present, slots in the Jordán stream cause permanent inflow of surface waters to underground and thereby changes of surface flow.

- *spoil banks near numerous adit collars on Dúbrava – Miková slopes*

Spoil banks from the mining activity are situated near every mine adit at various levels. The oldest spoils are localized in the highest parts of the massif, on the northern part of the Dúbrava ground elevation, near the old quarry. Material from the spoil banks is variated, from sand to boulders of 2.5 m size. Vegetation on spoils is very rare. Erosion processes of different intensities were documented there. In most cases flat and ravine erosion applied there, connected with slope flushing of
