The impact of land use/land cover change in suburban subdivisions on surface runoff: the case of the Gated Community Alto da Boa Vista (Federal District, Brazil)

Rebecca Costa SANTOS^{1*}, José Augusto Leitão DRUMMOND¹, Gustavo Macedo de Mello BAPTISTA¹

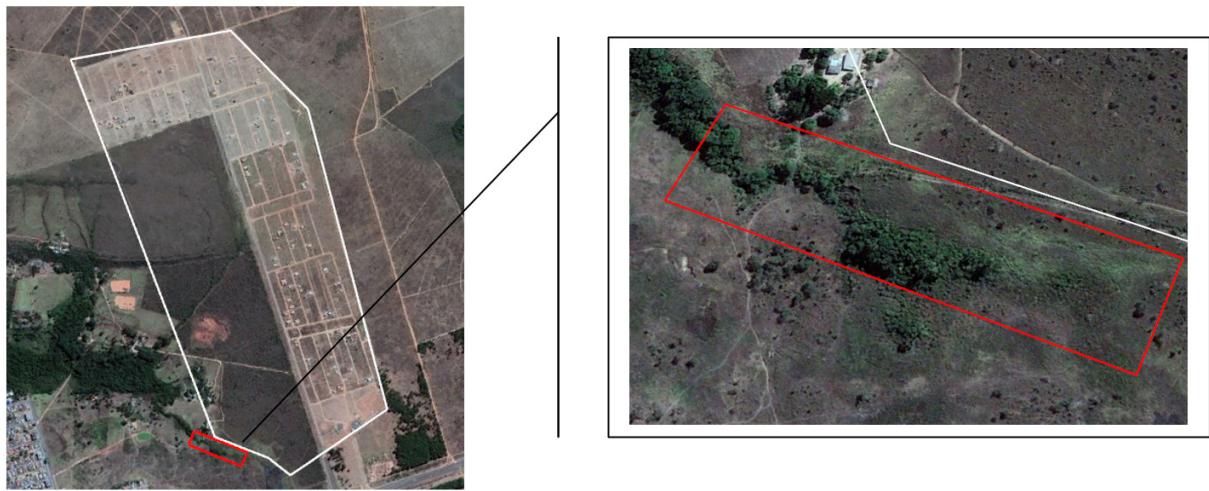
FIGURE 10 - The area recorded in the red rectangle in 2004 does not show a gully, which appears in 2015.

Concomitantly with the completion of land conversion in Areas 1 and 3 between 2015 and 2017, we recorded the formation of a gully outside the project, close to its southwestern border. Its beginning is visible when comparing images from 2014 and 2015 (Figure 10 and Figure 11). In Figure 10, vegetation is still dense, and there is no evidence of exposed soil in the humid area; however, in Figure 11, we see portions of exposed soil and reduced vegetation density.

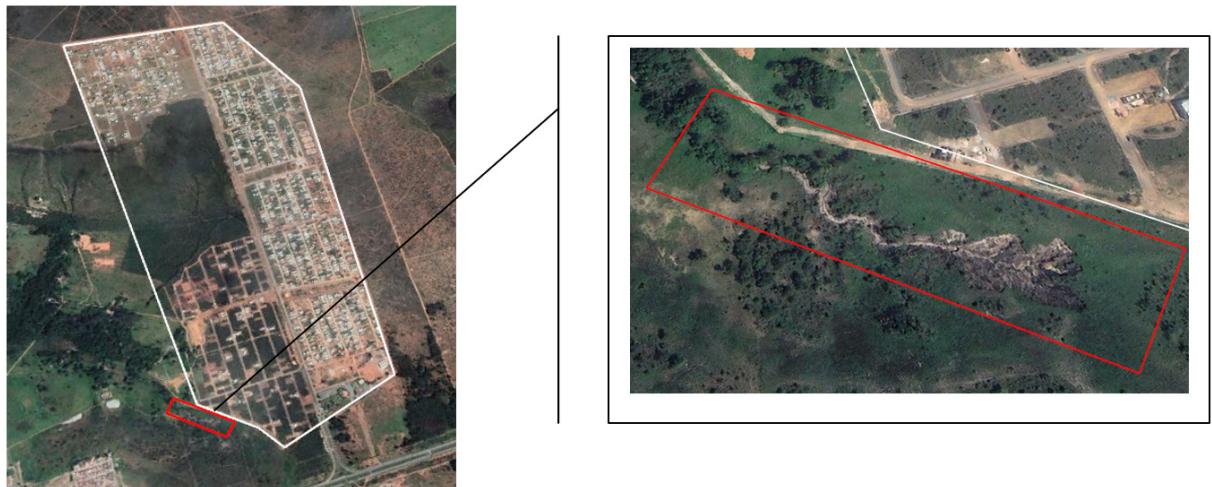
FIGURE 12 - In the red rectangle, the area affected by a gully in 2017.

Coinciding with the drastic reduction in infiltration in Area 3 (Figure 3), also present to a lesser extent in Areas 1 and 2, erosive features located on the limits of the community worsen and the area turns into a gully in 2017 (Figure 12). Until the appearance of the gully, the land undergoing erosion received contributions not only from Area 3 but from the entire area, since the project had not yet completed the drainage and rainwater management systems. Surface runoff went through the streets that

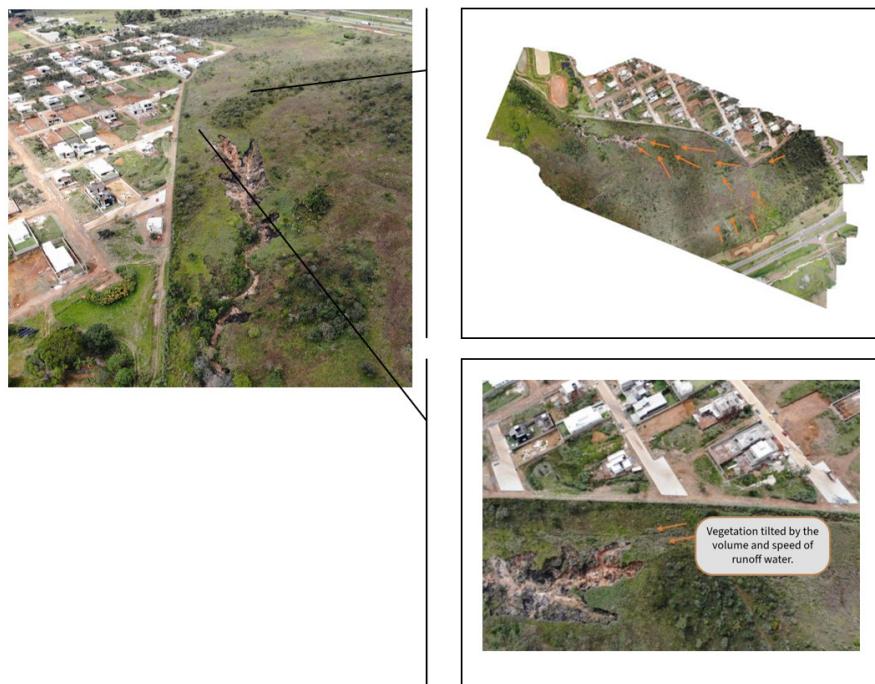
FIGURE 13 - Area reached by gully in 2020.

Analyzing the area more closely allows us to identify the behavior of the water flow on the ground that converges towards the erosive phenomenon (Figure 13).
