## EVALUATION OF THE MECHANICAL AND SURFACE PROPERTIES OF BRAZILIAN FILM FACED PLYWOOD PANELS

Film faced plywood panels represent an important solution for the civil construction industry, especially for use as concrete forms, due to their strength, durability, and the possibility of reuse. Considering the relevance of this material and the need to ensure the quality of products available on the market, this study aimed to evaluate the performance of film faced plywood panels produced by four Brazilian industries, focusing on their compliance with standards requirements for application in civil construction. The tests were conducted in accordance with ABNT NBR 17002 (density and static bending), ABNT ISO 12466 (glue line shear strength), and ABNT NBR 17001 (phenolic film evaluation). The results demonstrated that all panels met the minimum required standards, showing satisfactory performance across the different tests. The variations observed among the industries highlight the influence of factors such as panel density, veneer composition, and manufacturing parameters. It is concluded that the panels evaluated are technically suitable for use in civil construction, provided they a

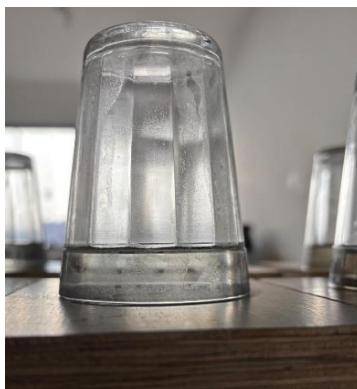
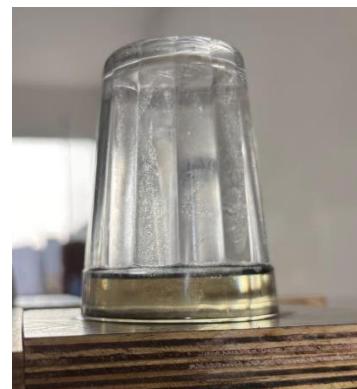
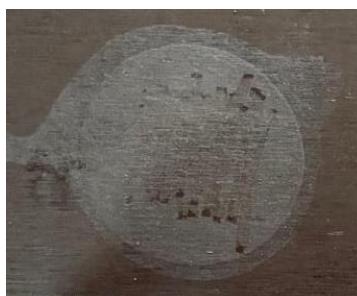
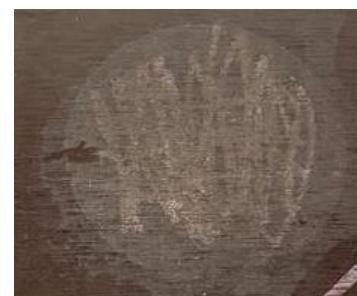
Solvent coloring  
(NaOH 5%)

Appearance of the  
tested surface

Legend: (a) Fully cured solvent (b) Nearly fully cured solvent (c) Fully cured film (d) Nearly fully cured film

The phenolic films applied to the panels from industries 2 and 4 showed superior performance, with 100% of the samples classified as "fully cured." This indicates that the solvent had a clear color and the surface was hard, smooth, and slightly whitish. Industry 1, on the other hand, showed 83% of the phenolic films as "fully cured" and 17% as "nearly fully cured." The "nearly fully cured" condition presented a slightly yellowish solvent hue and a slightly softened, slightly swollen, and yellowish surface. Industry 3 presented the lowest phenolic film coating performance, with 67% of the samples classified as "fully cured" and 33% as "nearly fully cured."

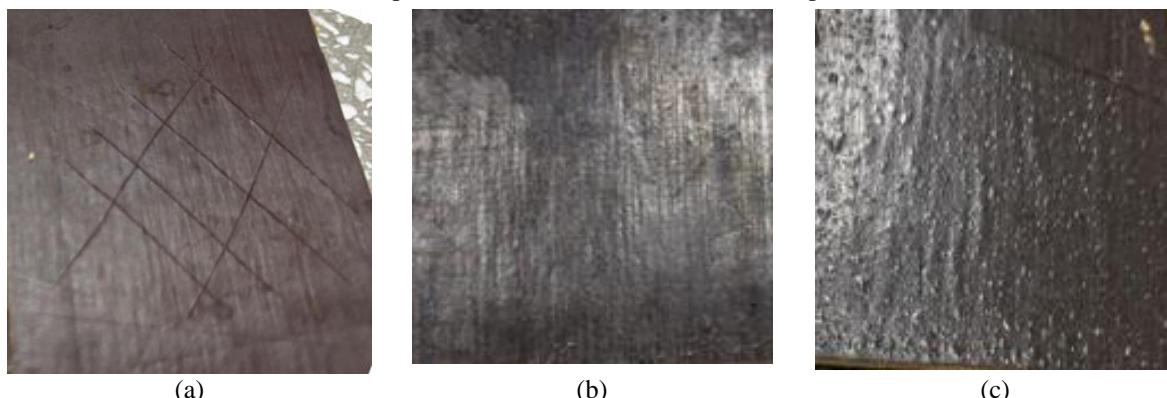
Figure 1. Sample safter phenolic film anchoring tests: (a) good adhesion using the cross-section method, (b) good adhesion using the boiling method. (c) poor adhesion using the boiling method.

In the cross-sectional method, all test specimens (100%) from all industries were classified as having good adhesion (Figure 1a), meeting the criteria established by the technical standard 17001 (2021). No removal of phenolic film particles from the panels was observed, and although removal of fibers or wood particles with the coating is permitted by the aforementioned standard, no such removal was evidenced.

In the boiling method, industries 1, 3, and 4 showed 100% of the test specimens with good adhesion, as shown in Figure 1b, with no bubbles on the surface. It is also worth noting that good adhesion or anchoring allows for small bubbles in the coating. Industry 2, however, showed 8% of the test specimens with poor adhesion (1 panel out of 12), with bubbles observed after boiling (Figure 1c).
